# **GALAPAGOS ISLANDS ECUADOR UPPER AIR STATION**

### **HYDROGEN PLANT INSTALLATION**

### **METEOROLOGICAL SERVICE OF NEW ZEALAND LIMITED**

*8 December 2004*

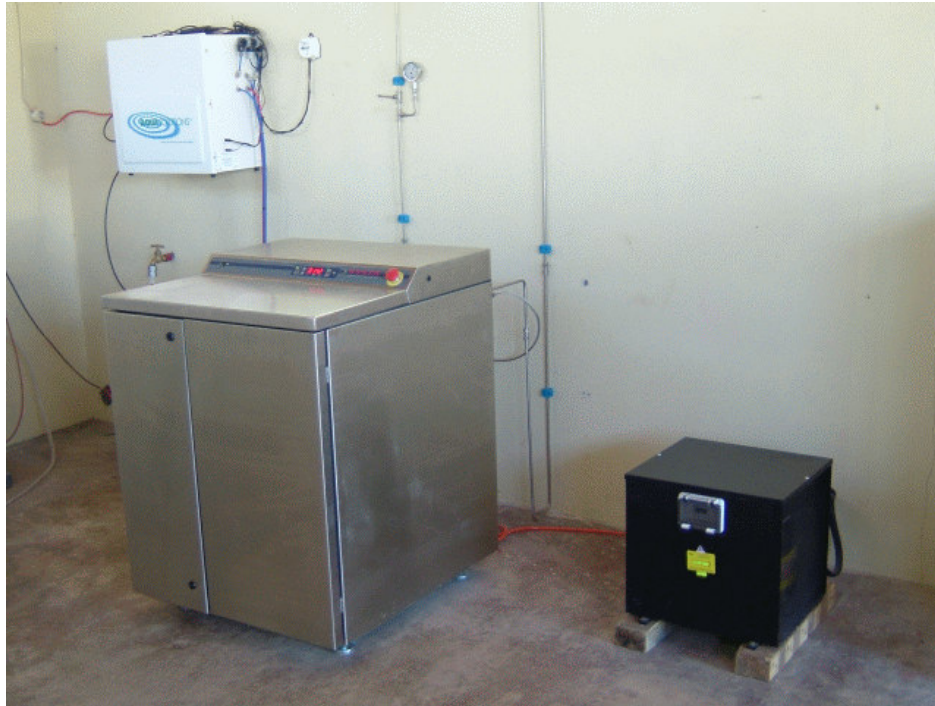
*AquaSolutions system, Proton Hogen 20, related plumbing and gas lines, and transformer after installation*

This was installed in the store room, adjacent to but separated by two doors from the balloon filling room, as per the drawing. The hydrogen vent was fed up the wall and through the roof. Oxygen and water drain lines were also fed out through holes in the wall.

Wall mounted in the corner of the store room, adjacent to the Hogen. To improve water storage capacity, a second RO storage tank was purchased. This however, arrived without a valve assembly, so was not installed at this time.

Mains power regulation at the station was very poor, necessitating the use of a power transformer to convert 2 phase 110V (in practice 175V) to single phase 220V. This was installed on the floor next to the Hogen 20. A new power cable was installed from two new 40A circuit breakers on the main station switchboard, directly to the power transformer. The cable was enclosed in plastic tubing. Two earth stakes were driven, and these were bonded to the power transformer, the Hogen, and the storage tanks. An existing 110V circuit in the store room was extended to provide power to the AquaSolutions unit.

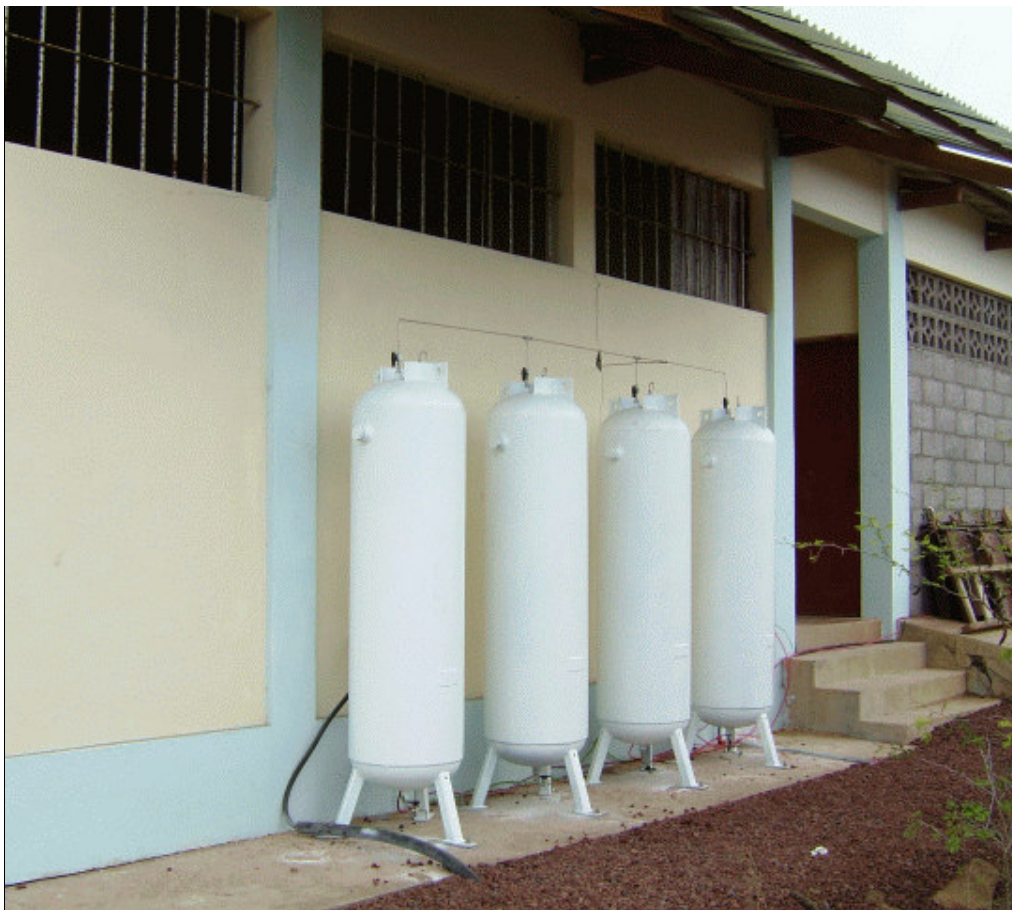
*Tanks and plumbing installed, and cables and pipes covered by volcanic scree*

Four new Niven 250 l tanks were positioned in line against the outside wall, and bolted down as per manufacturer's instructions. Because of surface damage that occurred to galvanising coating during shipping, tanks were painted.

Stainless steel Swagelock fittings and tubing were used to connect them together, back to the Hogen, and to the filling room. A Swagelock change over valve (centre off) was fitted between the M28 system, the Hogen, and the balloon filler.

The tanks were filled with water, and all joints tested for leaks at 200 psi before purging.

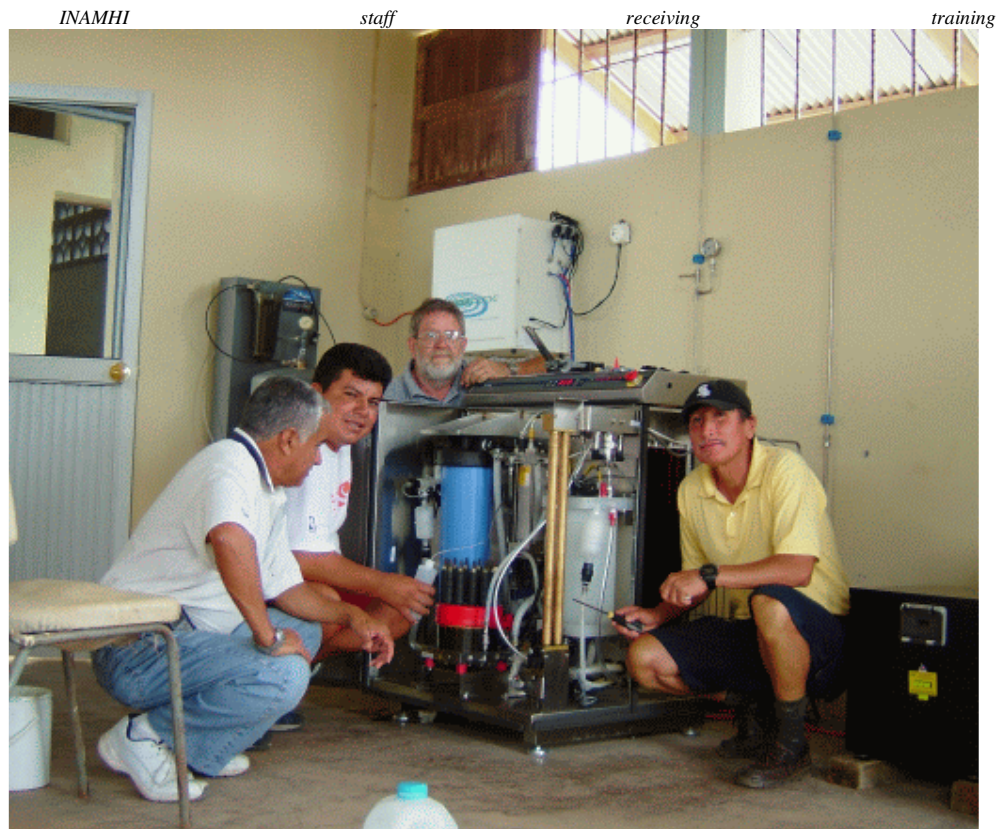
Extensive training was carried out with local staff, both during the installation and commissioning stages, and during semi formal sessions afterwards using training guides and manuals. Considerable time was spent in practical aspects, including problem identification, GC calibration, and module replacement. The Proton fault necessitated stripping the Hogen 20 down and this afforded additional practical training.

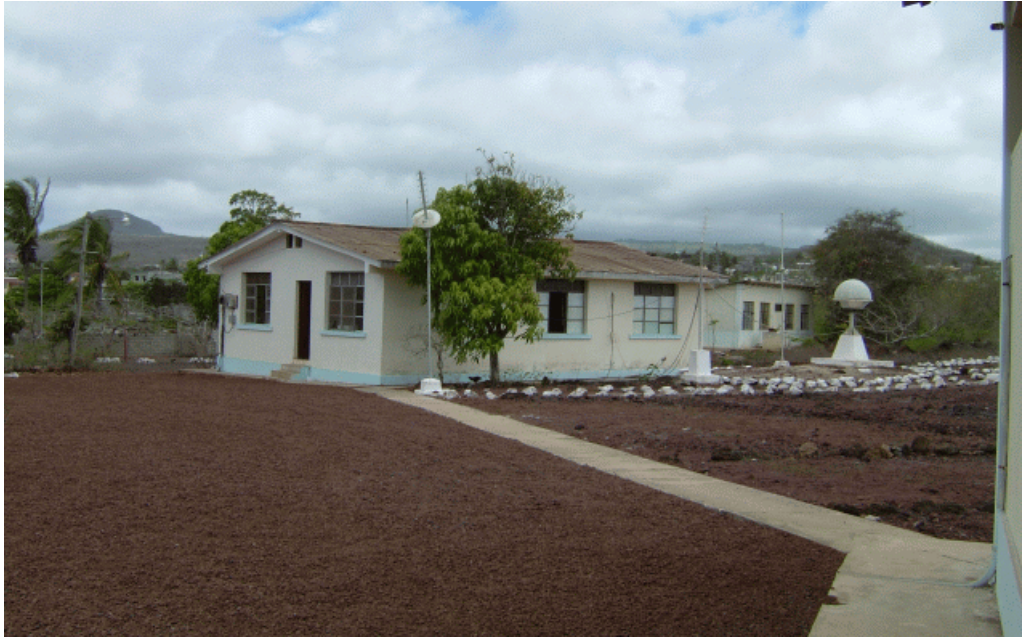
*Volcanic scree covering cables and water lines between office and hydrogen building; and providing landscaping*

- Because of the nature of the ground, digging to bury the power and water lines would have been very difficult, if not impossible. It was decided that a few cubic metres of volcanic scree would be a good alternative, and provide some much needed landscaping.
